Debris/Ice/TPS Assessment And Photographic Analysis For Shuttle Mission STS-43

DEBRIS/ICE/TPS ASSESSMENT
AND
PHOTOGRAPHIC ANALYSIS
OF
SHUTTLE MISSION STS-43

August 2, 1991

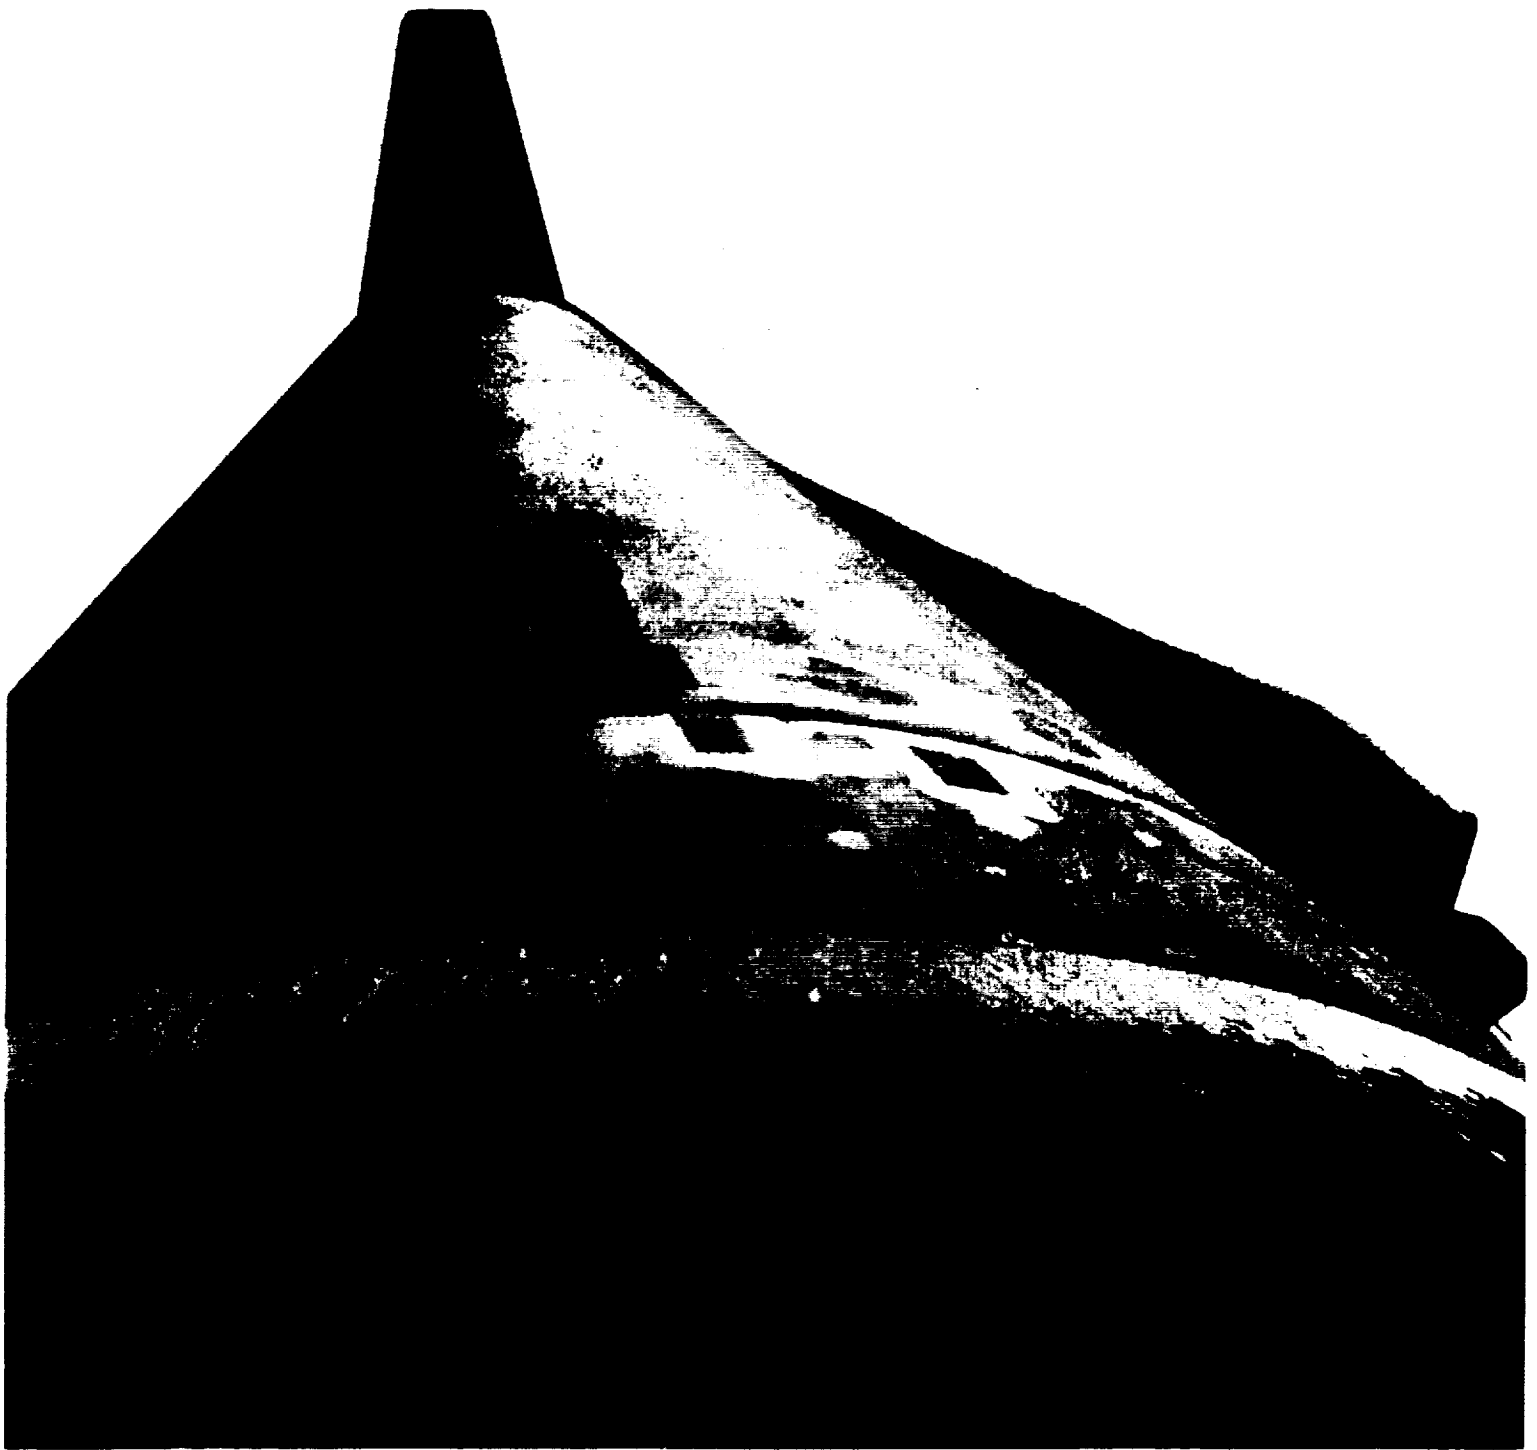
The tumble valve cover was intact. There were no anomalies on the nosecone, fairing, louver, and footprint areas.

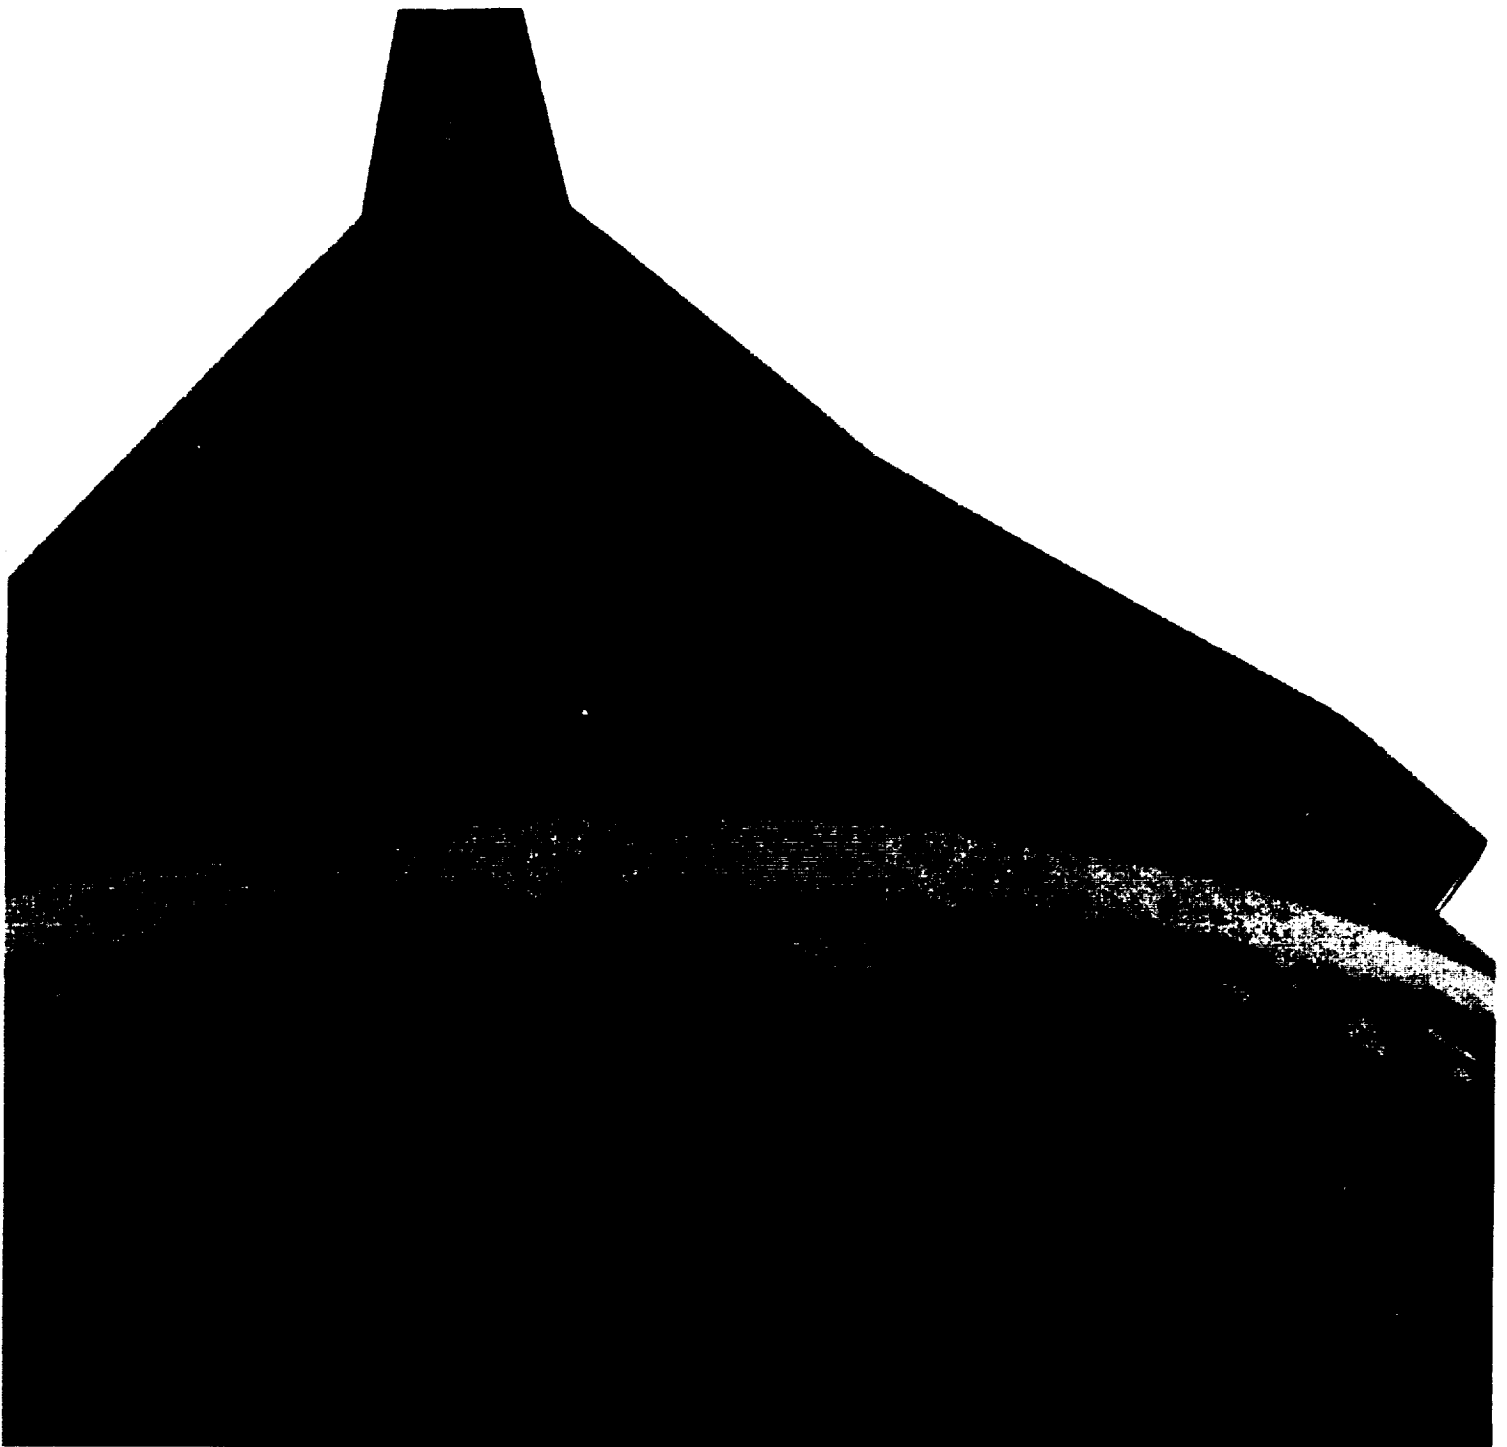
The tumble valve cover was intact. There were no anomalies on the -Y side of the nosecone, fairing, louver, and footprint area. The nosecone +Y side was not accessible for inspection.

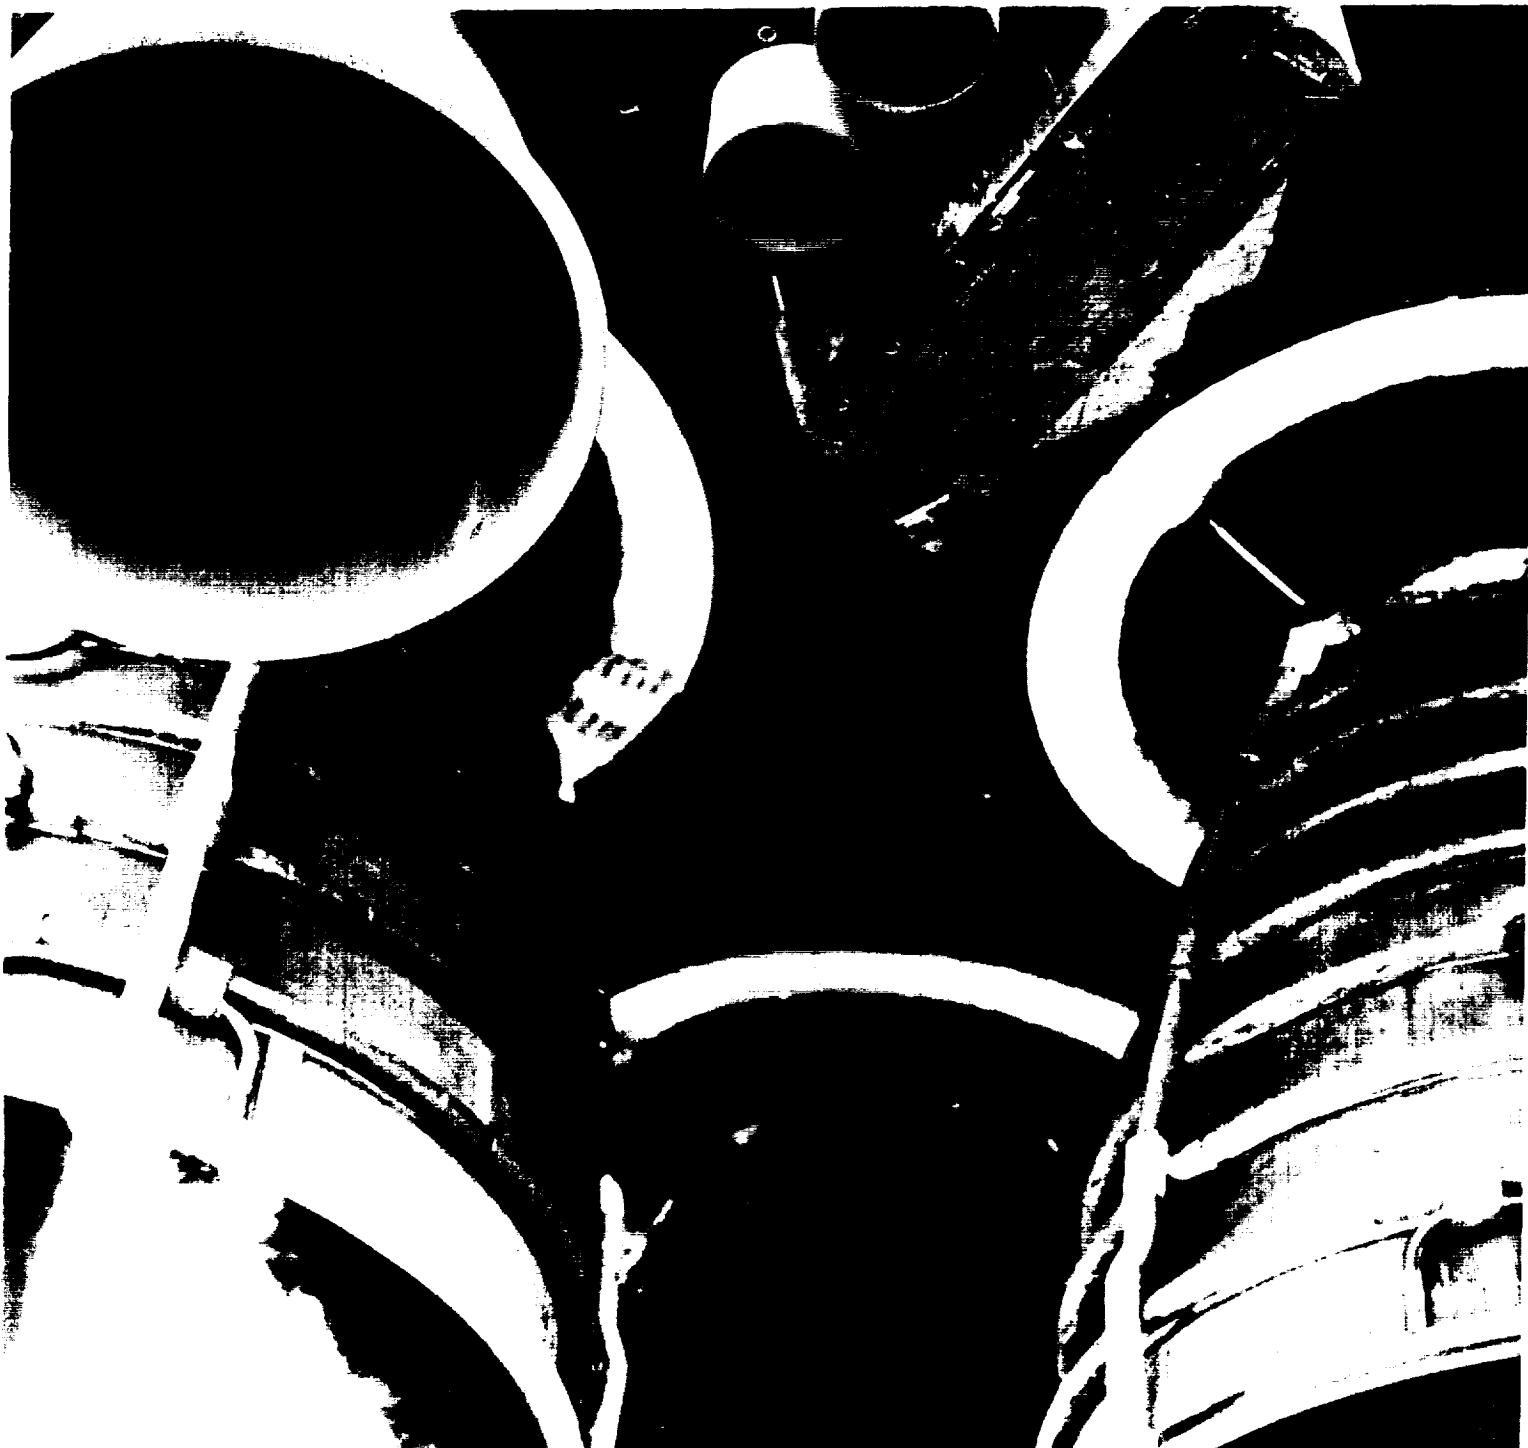
Overall view of the SSME cluster and RH OMS nozzle. Some ice/frost had accumulated at the SSME #1 and #2 heat shield-to-nozzle interfaces.

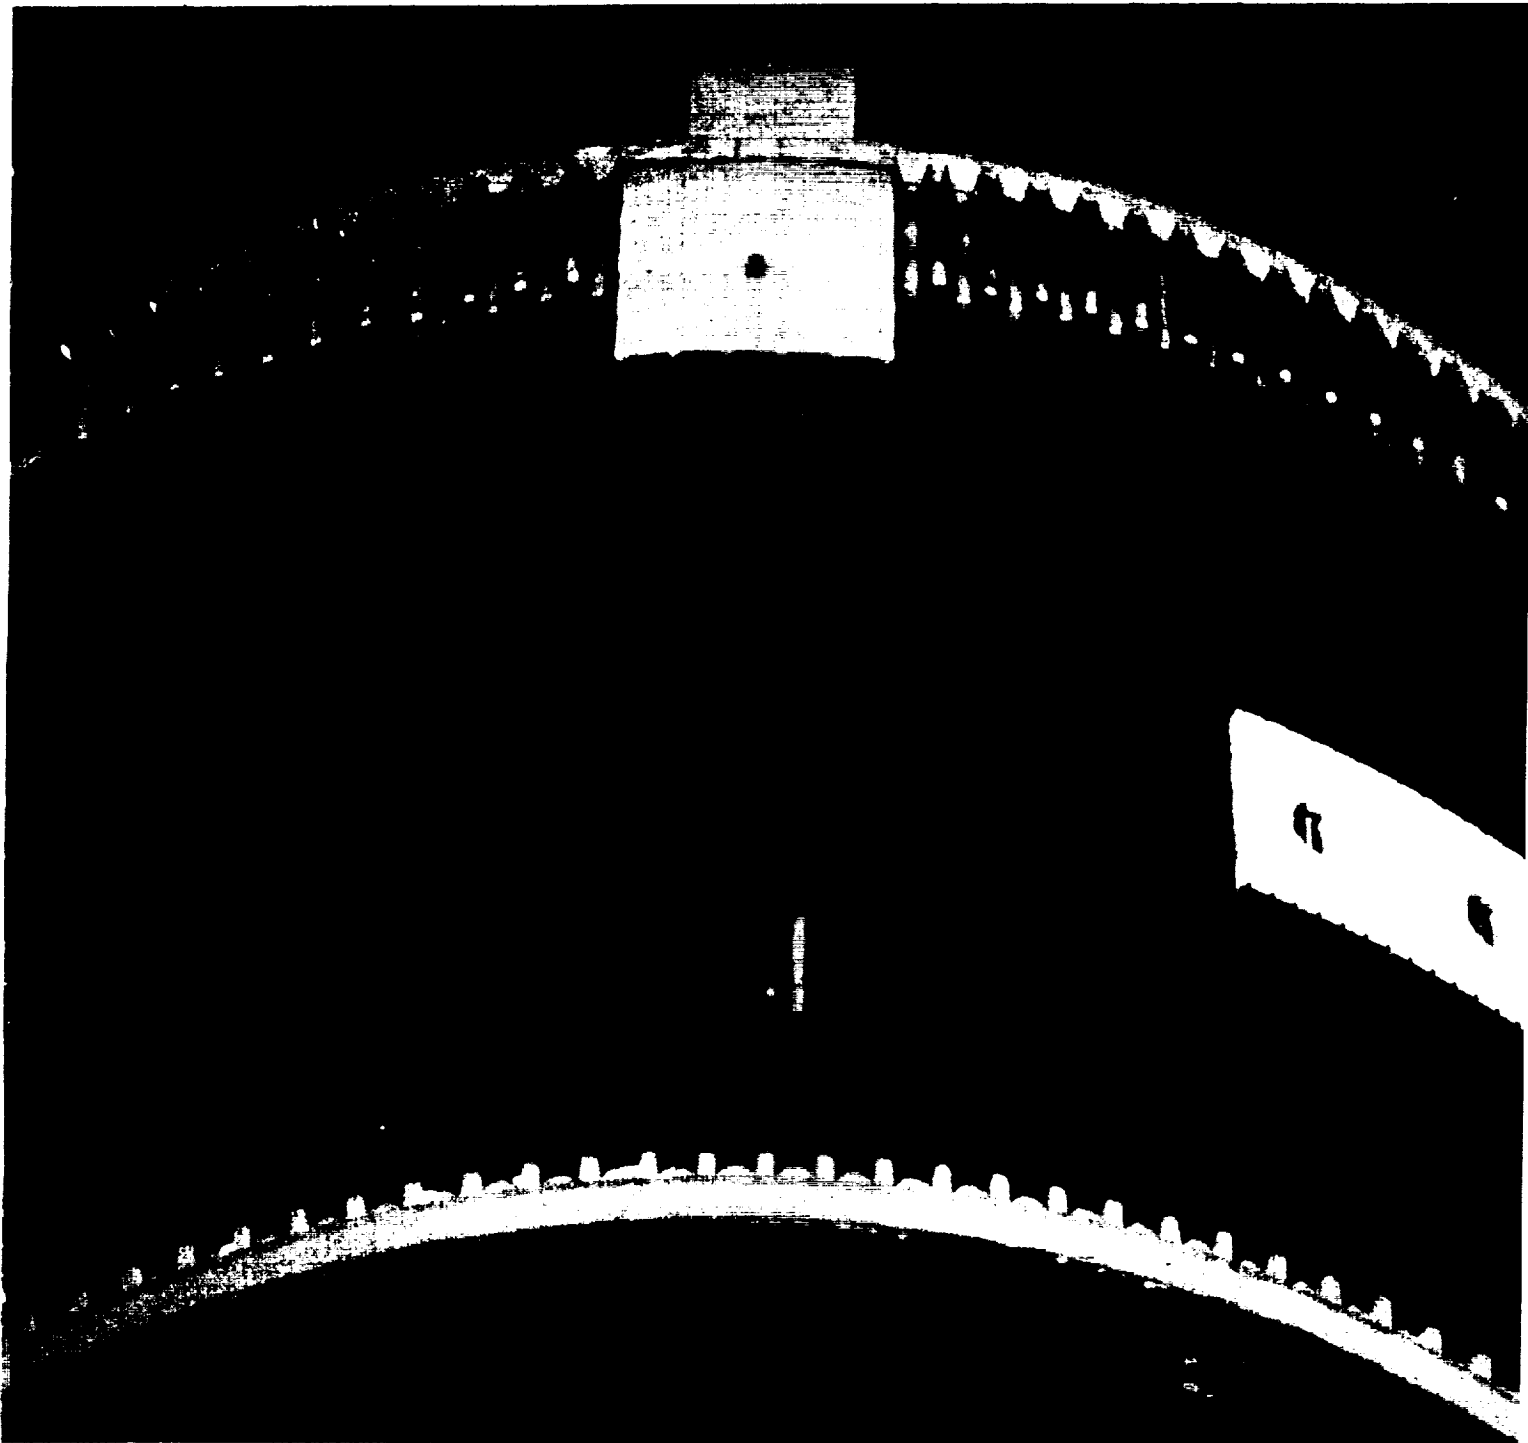
The intertank TPS acreage was wet with run-off condensate. There were no TPS anomalies. Numerous small scattered frost spots appeared in the stringer valleys at both LH2 and LO2 tank -Z flanges - an acceptable condition per NSTS-08303.

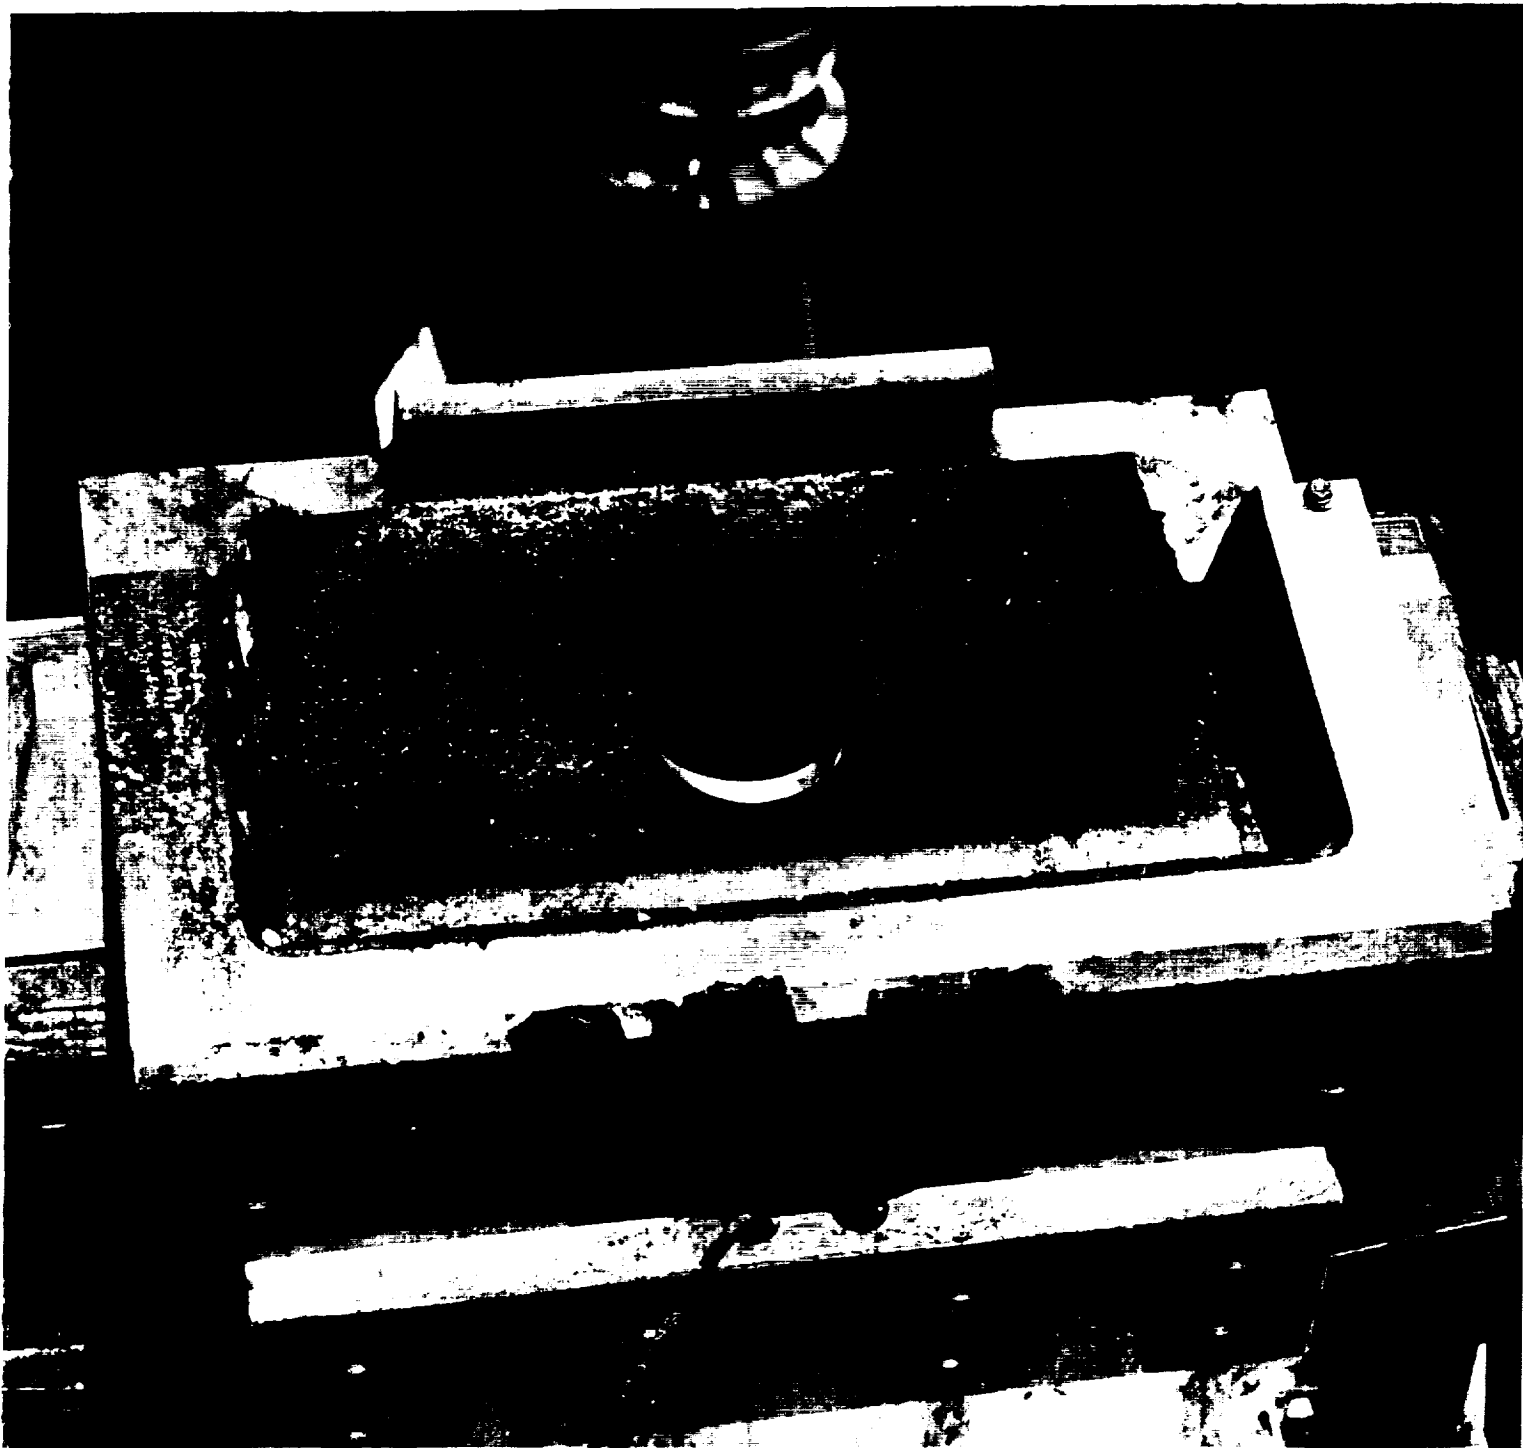
Plume erosion of the south SRB holddown posts was typical. All EPON shim sidewall material and shim bottom plate material was intact and bonded to the shoes. There was no visual indication of a stud hang-up on any of the south holddown posts.

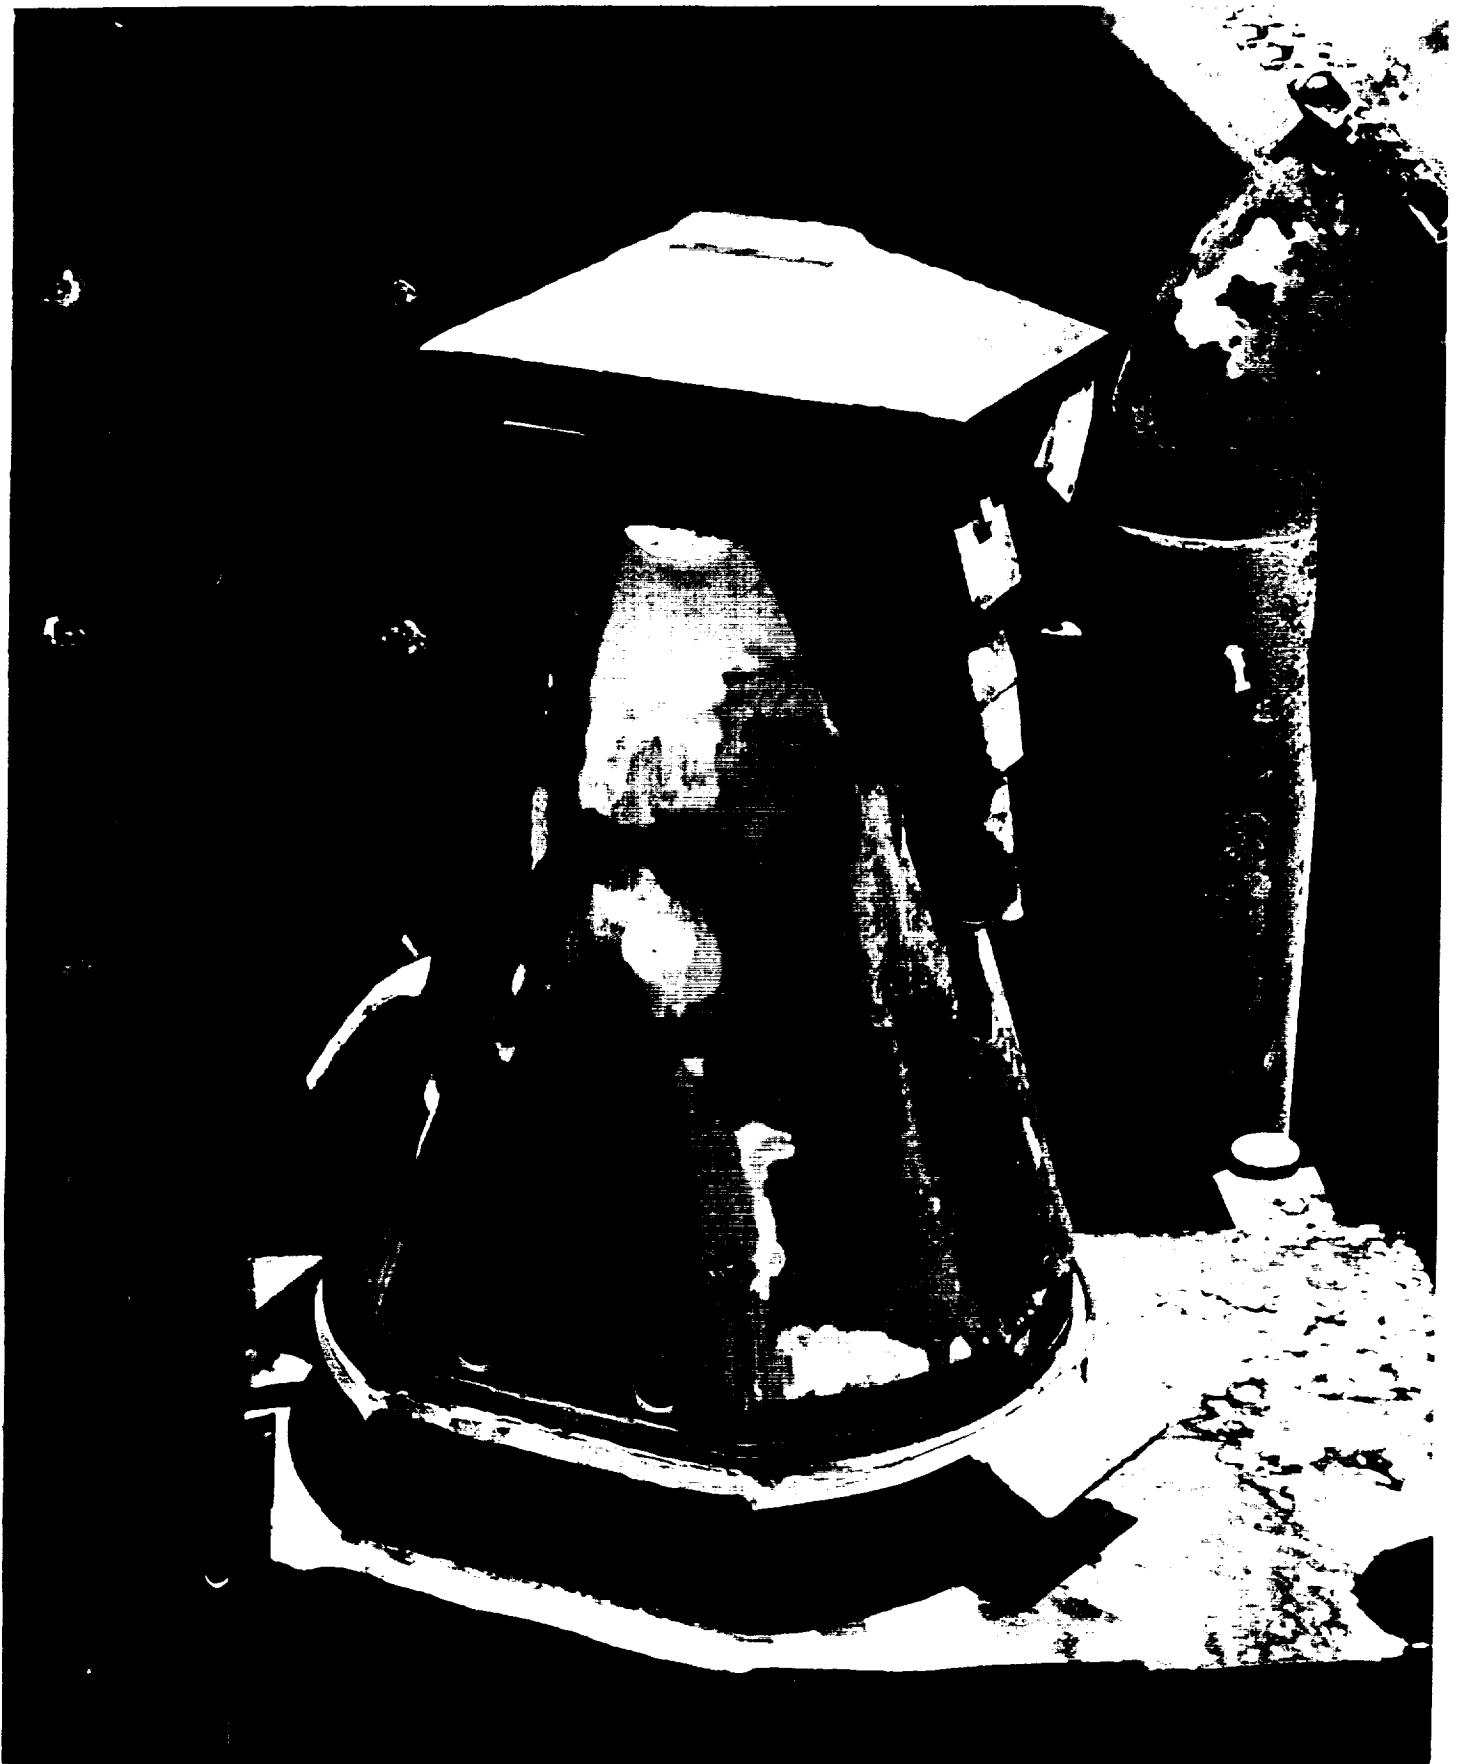
North HDP blast covers were in the closed position and exhibited typical plume erosion effects

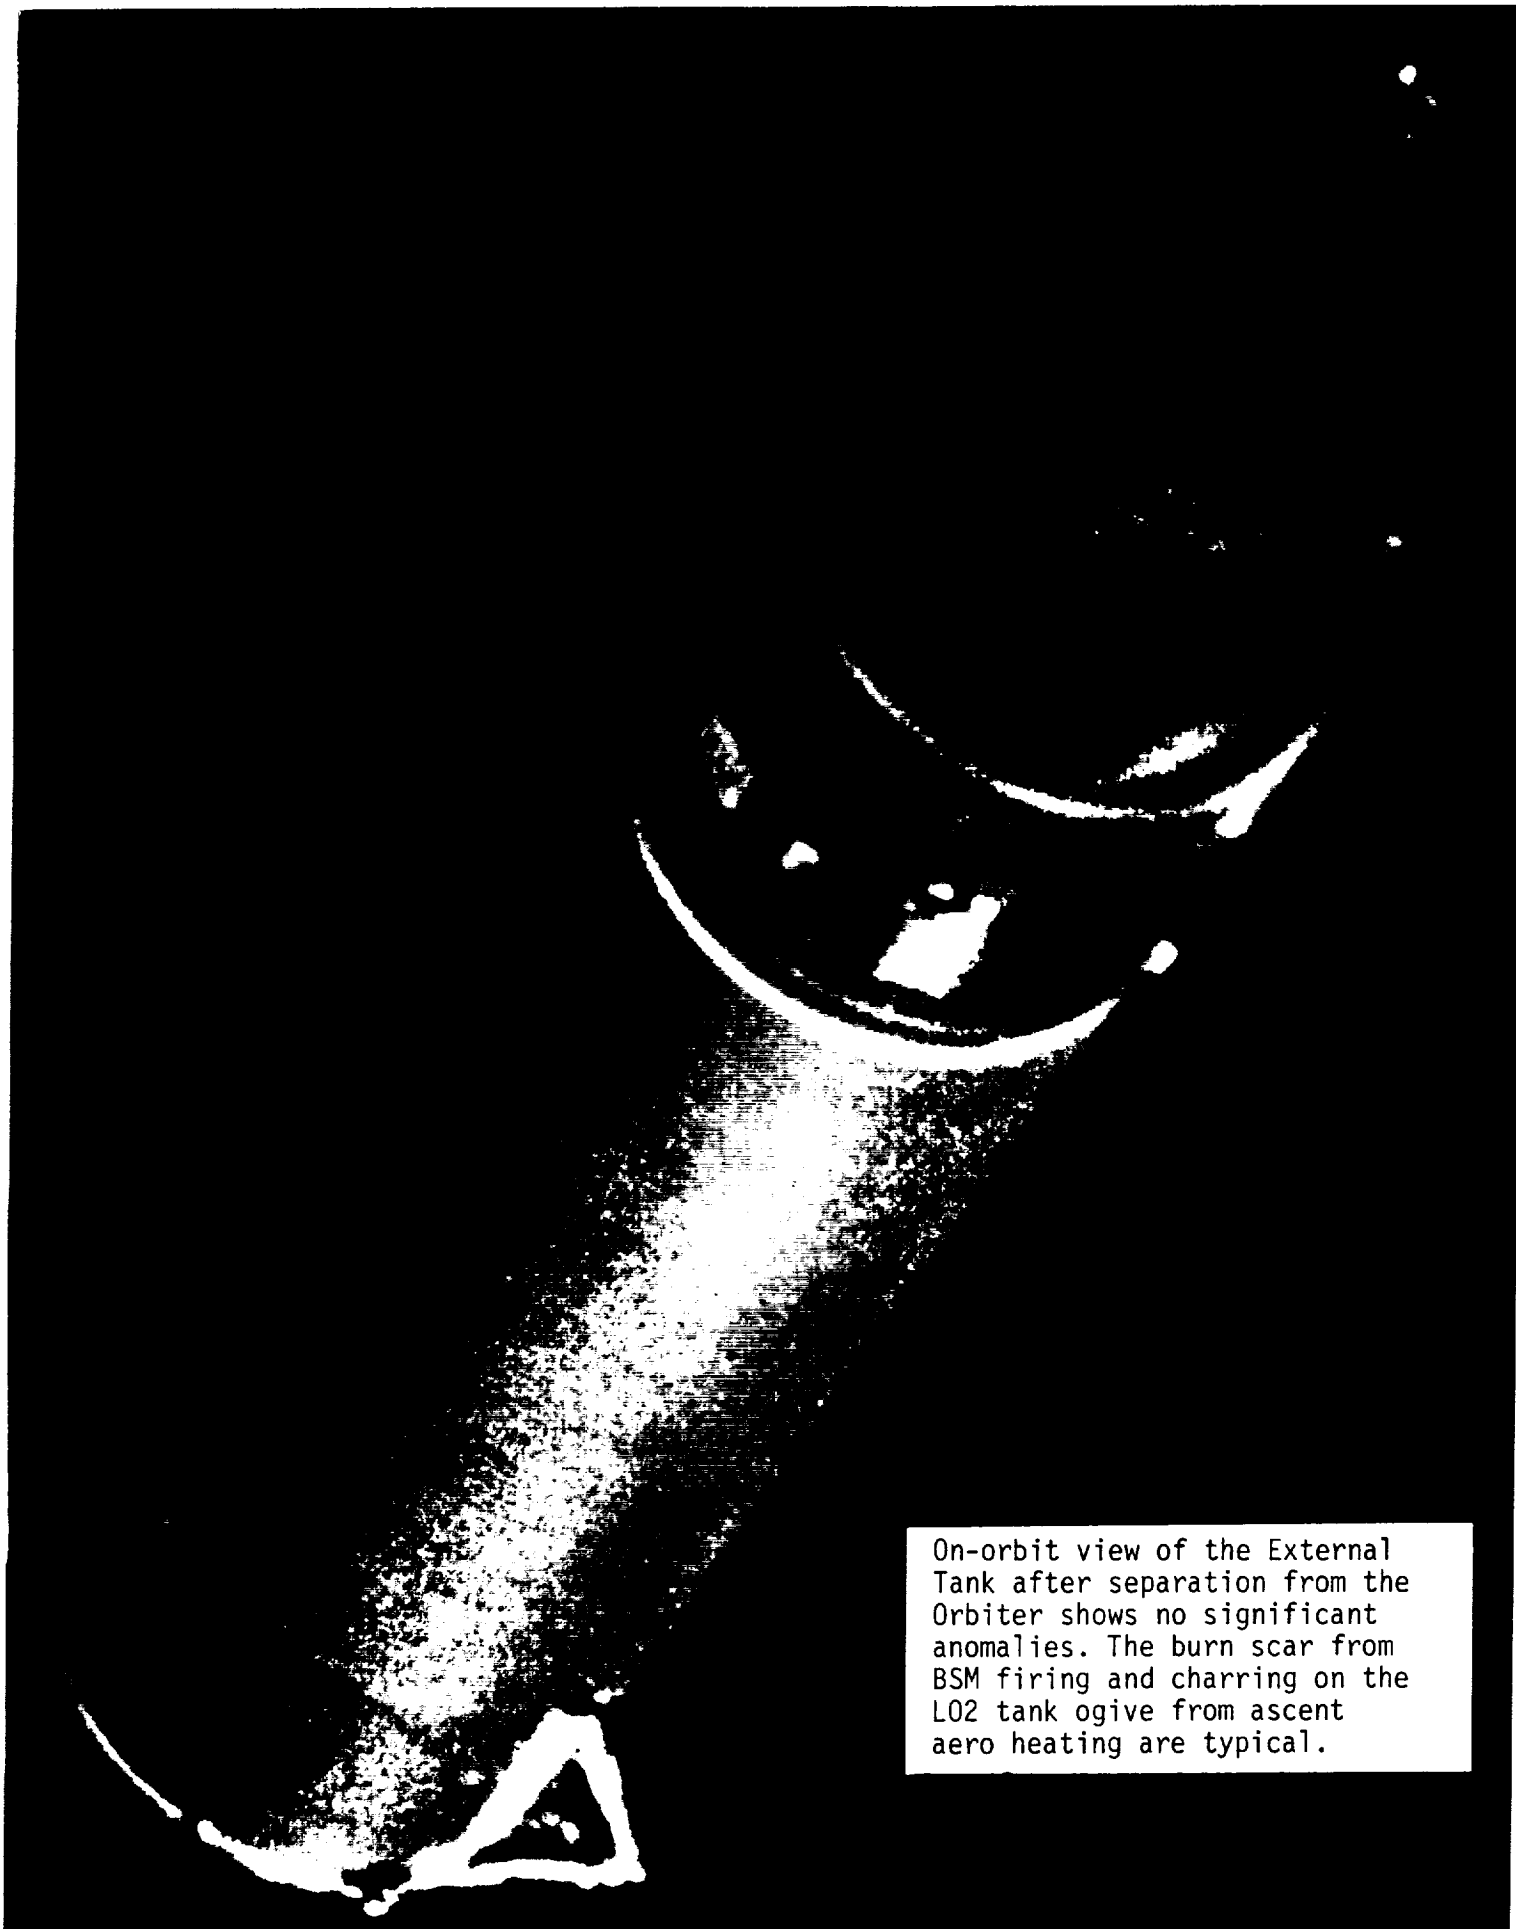
On-orbit view of the External Tank after separation from the Orbiter shows no significant anomalies. The burn scar from BSM firing and charring on the LO2 tank ogive from ascent aero heating are typical.

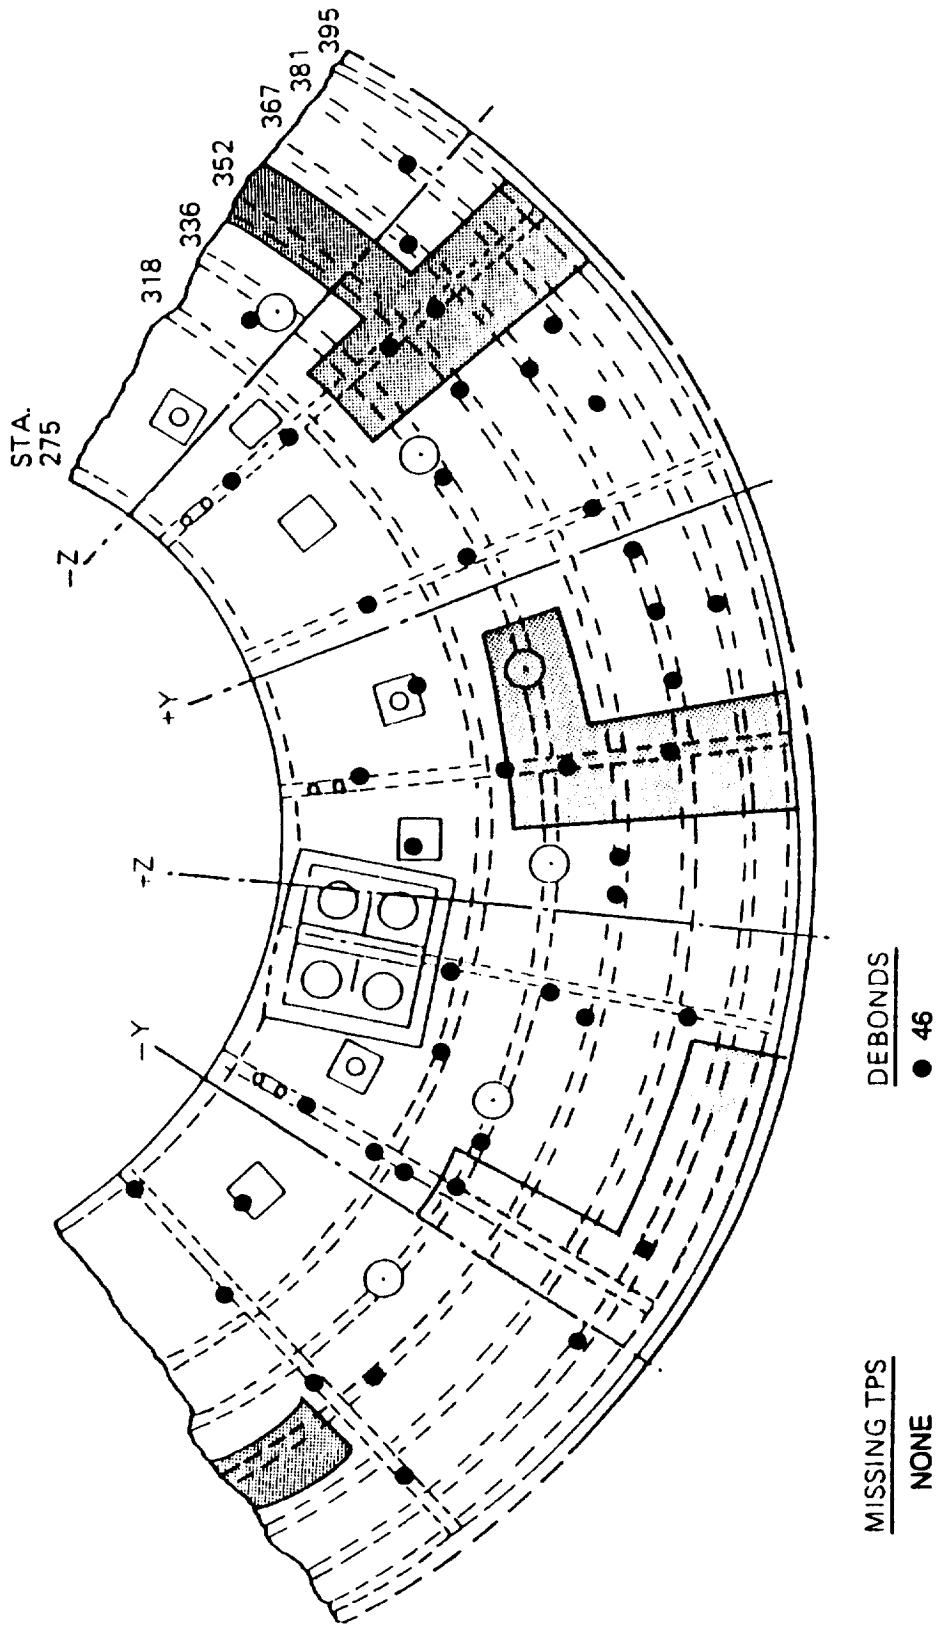
FIGURE 9. RIGHT SRB FRUSTUM

The RH frustum was missing no TPS but had 46 MSA-2 debonds over fasteners. There was minor localized blistering of the Hypalon paint (Figure 9). The BSM covers were locked in the open position, but the two LH covers were bent upward by parachute riser entanglement.

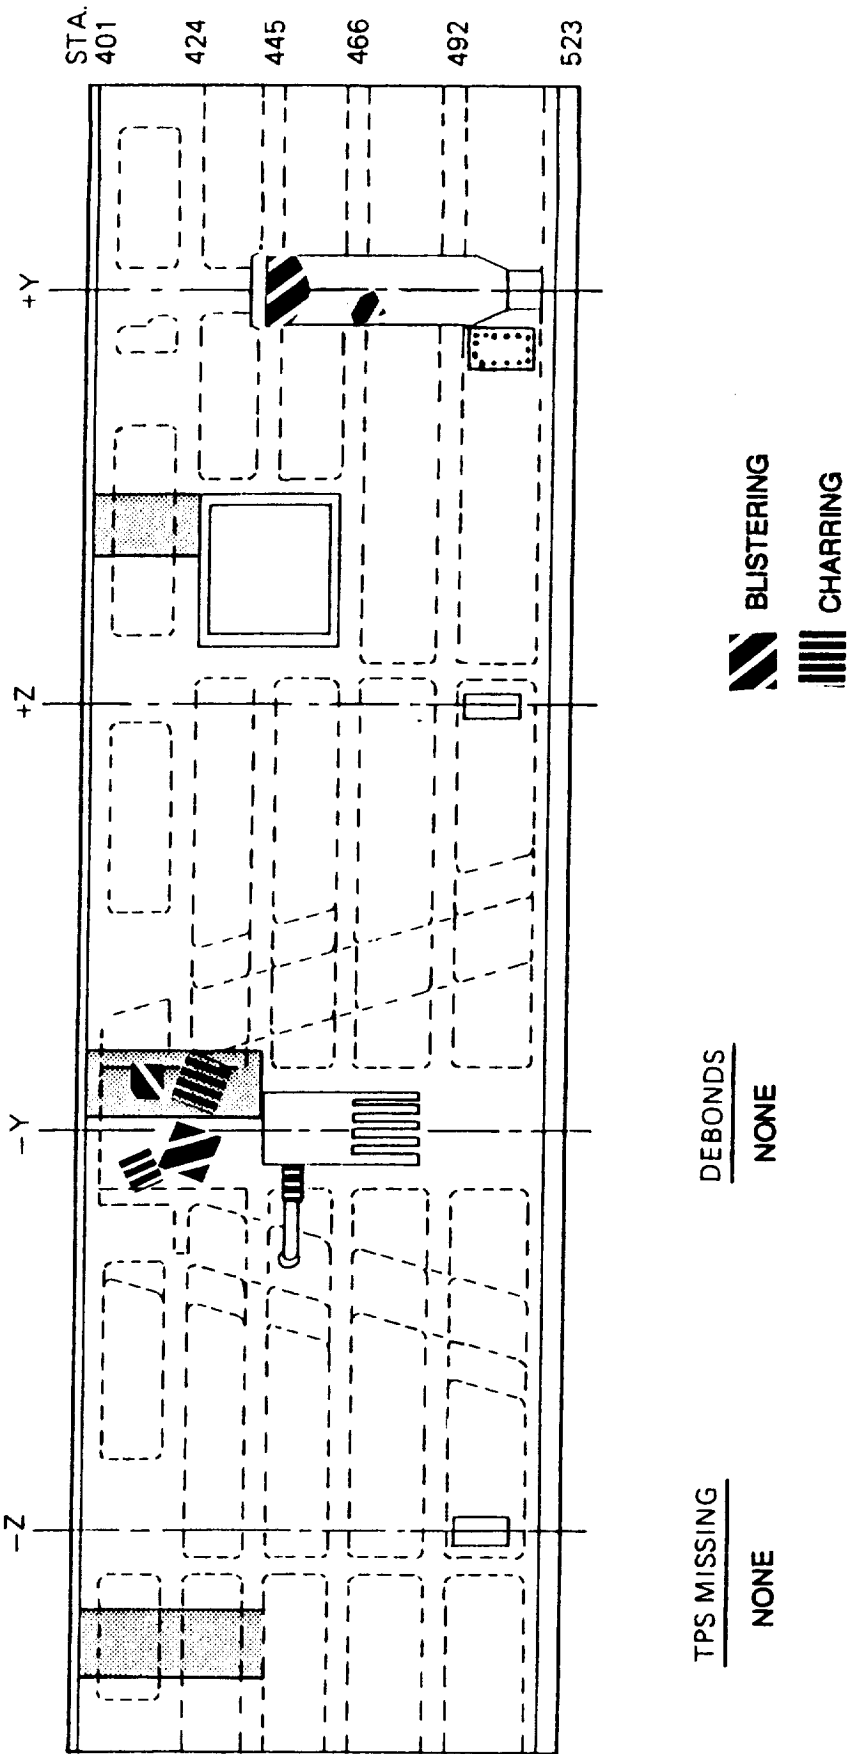
FIGURE 10. RIGHT SRB FWD SKIRT

The RH forward skirt exhibited no debonds or missing TPS. The phenolic plates on both RSS antennae were intact. The forward separation bolt and electrical cables appeared to have separated cleanly. No pins were missing from the frustum severance ring. Minor blistering of the Hypalon paint occurred forward of the ET/SRB attach point (Figure 10).

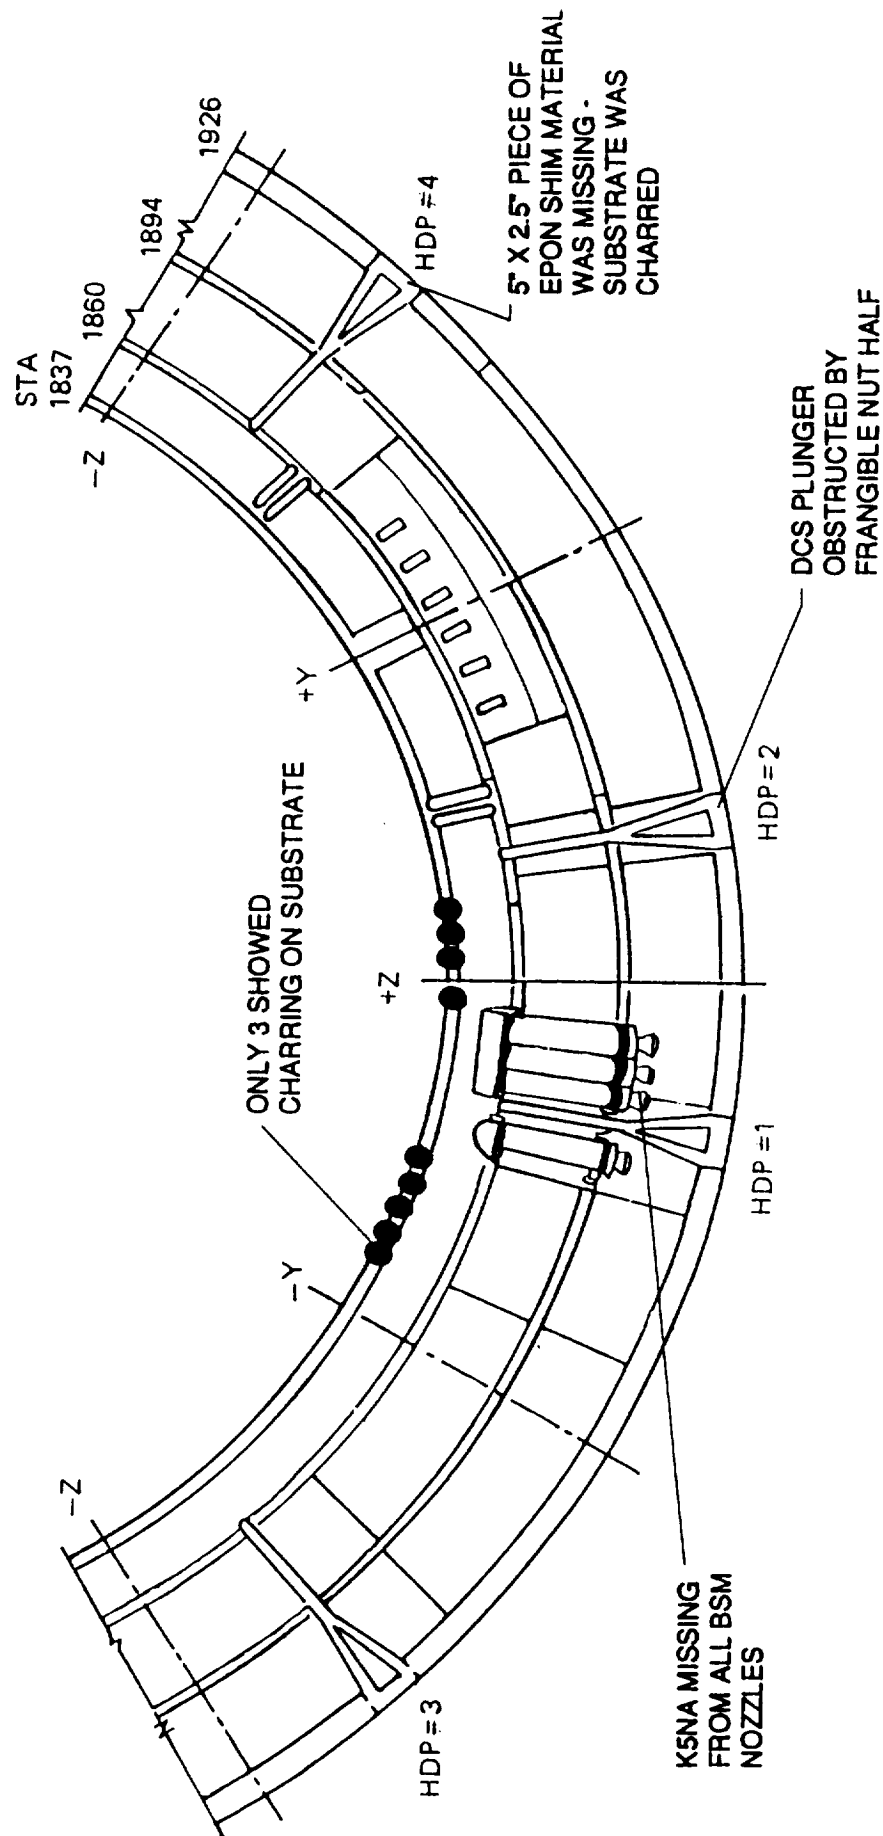
FIGURE 11. RIGHT SRB AFT SKIRT EXTERIOR TPS

The phenolic material on the kick ring delaminated at only a few locations. Three K5NA protective domes were lost from bolt heads on the aft side of the phenolic kick ring near HDP #3 prior to water impact. The aft skirt acreage TPS was in good condition (Figure 11). K5NA was missing from all of the aft BSM nozzles. Three of four HDP Debris Containment System (DCS) plungers were seated properly. The HDP #2 plunger was obstructed by a frangible nut half. This was the second flight utilizing the optimized link. All of the HDP #3 EPON shim material was intact. Most of the HDP #4 EPON shim material was lost at water impact except for a 5"x2.5" area, which showed a charred substrate.

● MISSING K5NA PROTECTIVE DOMES
